# The Immense Cost of Japanese Dams and Dam-Related Landslides and Earthquakes [Chinese text available] ダムと地すべりに浪費される巨費 まさのあつこ

Masano Atsuko

Translated by Aaron Skabelund

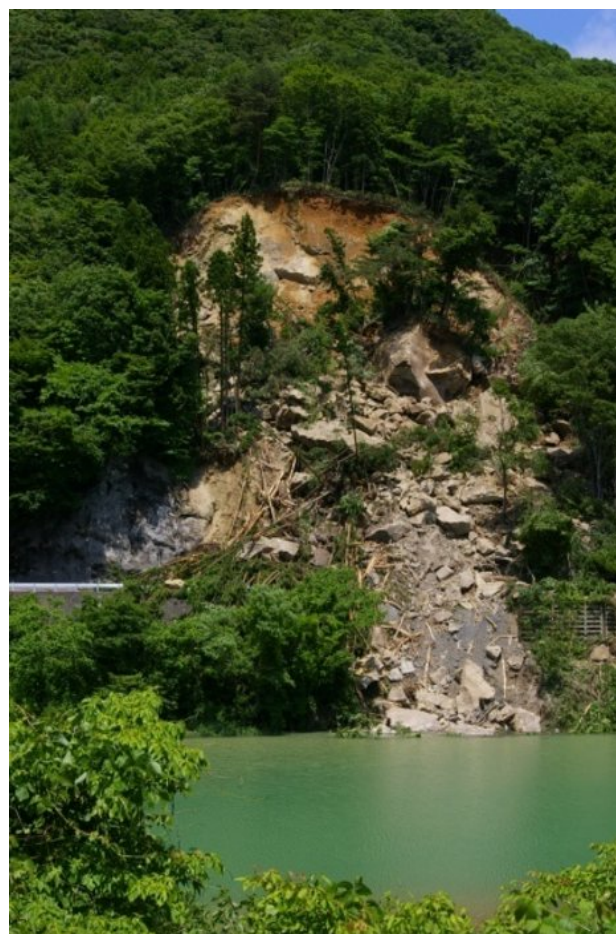
The Iwate-Miyagi Nairiku Earthquake

In this landscape carved by rivers, a landslide with an average depth of 55 meters, a width of 810 meters, and a length of 1400 meters slid as far as 140 meters off the side of the mastiff and into the back of the lake formed by the dam.

University Professor Konagai Kazuo appeared on NHK television's "Close-up Gendai" special, "The Mountain that Disappeared: The Iwate-Miyagi Nairiku Earthquake," and explained that because ground water near the dam was high and because snowmelt had permeated the ground, the violent shaking of the earthquake had caused the massive landslide.

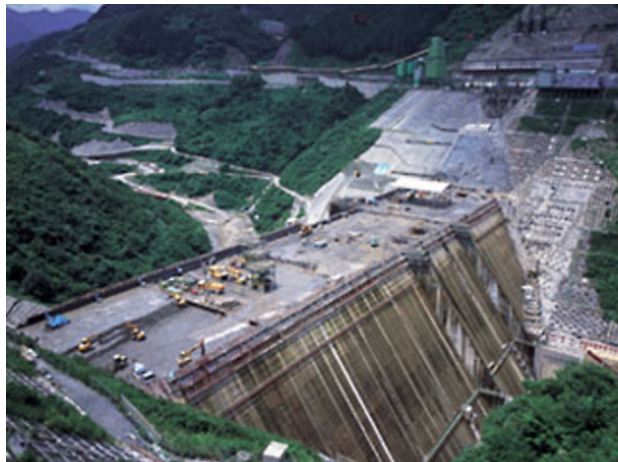
### **Takizawa Dam, second construction**

the water level was 16 meters away from being full. A half month later, the slope—now 90 meters wide, 90 feet deep, and 15 meters long—slid further. In response, Kurihara Yoshiharu, the assistant director of the agency announced, “We knew that this was an area susceptible to landslides and while keeping the water level down, we had taken preventive measures such as constructing an embankment.” A visit to the area confirms evidence that the agency had taken all sorts of measures in no less than 40 different places. The agency had “combined the best construction techniques,” said Kurihara, yet this was insufficient.

Prevention measures continued and in August 2007 another attempt was made to fill the reservoir. This time, workers were able to fill it to capacity, but as they began to lower the water in April 2008, a crack was discovered in a city road near the reservoir bank. As the water continued to be lowered, other fissures appeared. On 7 May, a 40 centimeter diameter crack was found on Route 140 on the other side of the reservoir and six days later another was discovered in a concrete barrier. Even when the water level was maintained, the land continued to slump. On 13 June, a crack appeared in another city road as the slope dropped by .4 meters. When I visited Saitama,

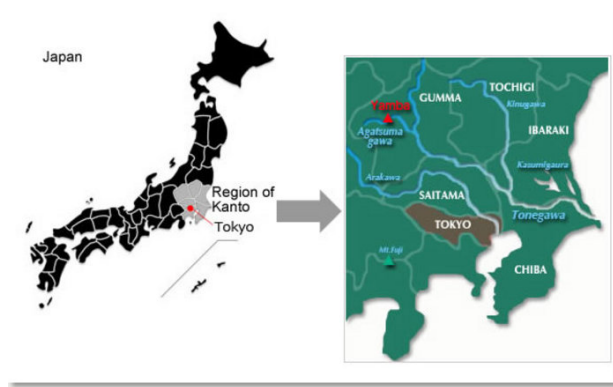
**Yamba Dam map**

The Transportation Ministry has designated the slopes around the reservoir site as susceptible to landslides and determined that 22 locations are likely to weaken when the reservoir is filled. In the end, however, the ministry decided to take preventive measures in just six spots “where stored water is highly likely to lead to landslides.” The region around the dam has been repeatedly subject to volcanic activity, and, as is even reported on the Transportation Ministry’s website, it is the location of a hydrothermally-altered zone. Areas that have such a zone and experience other volcanic activity are particularly vulnerable to landslides.
